# *Little Goose Dam*

## *Radial Gate Inspection and Testing*

US Army Corps of Engineers, Walla Walla District

13. ABSTRACT (Maximum 200 words) This report is an evaluation of the overall condition of the spillway tainter gates at Little Goose Lock and Dam, Snake River Washington.				
20030313 194

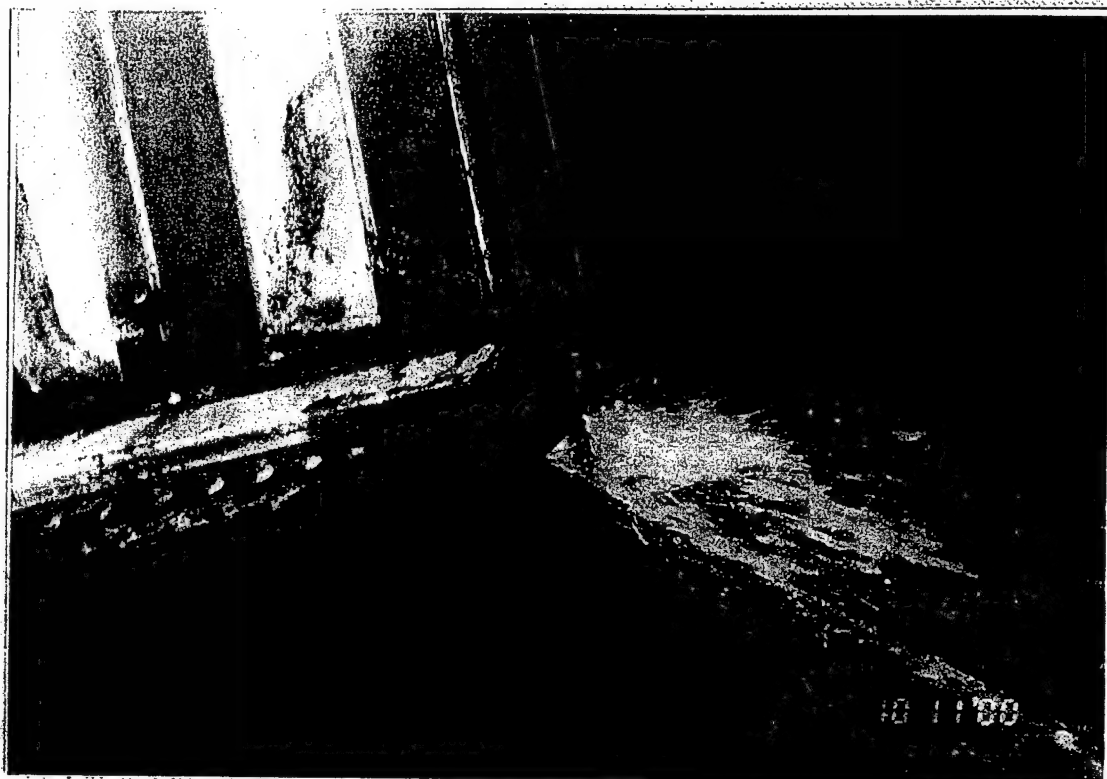
5-9

Gate 5  
Leak at center construction joint in  
spillway monolith.

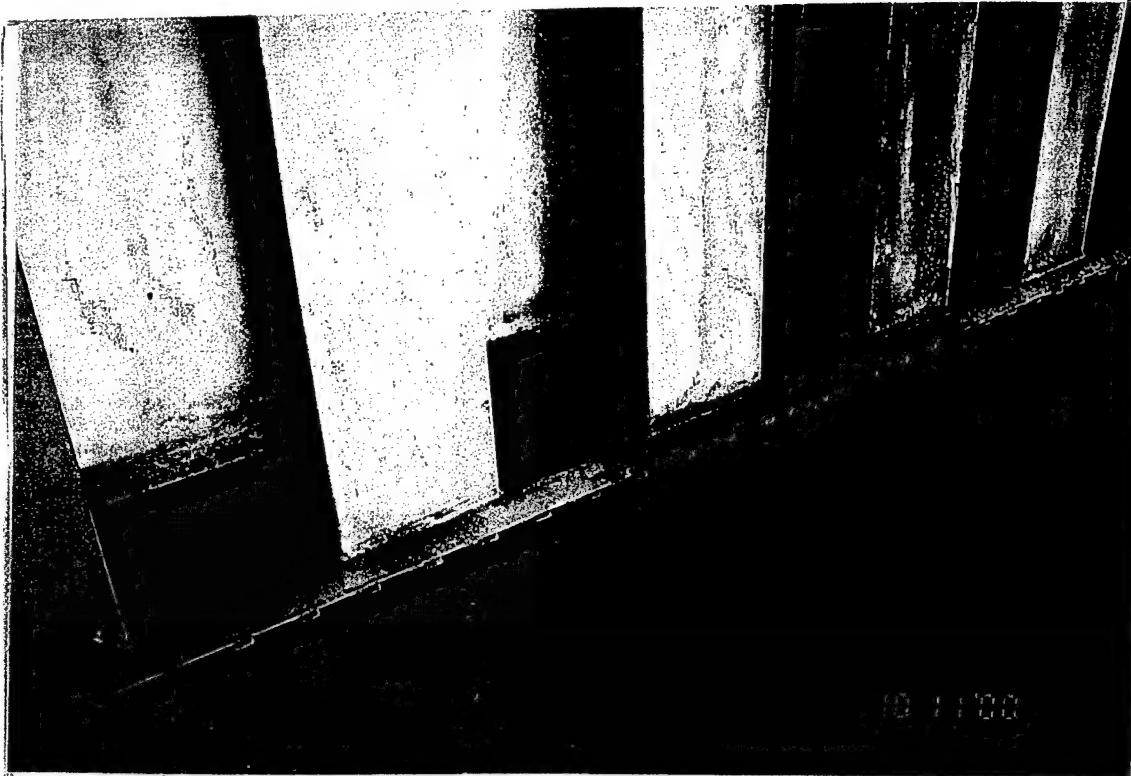
5-10

Gate 5  
Bottom left corner of gate, bottom  
seal leak. Bottom seal closure plate.  
Standing water between closure plate,  
purlin webs and skinplate, typical.

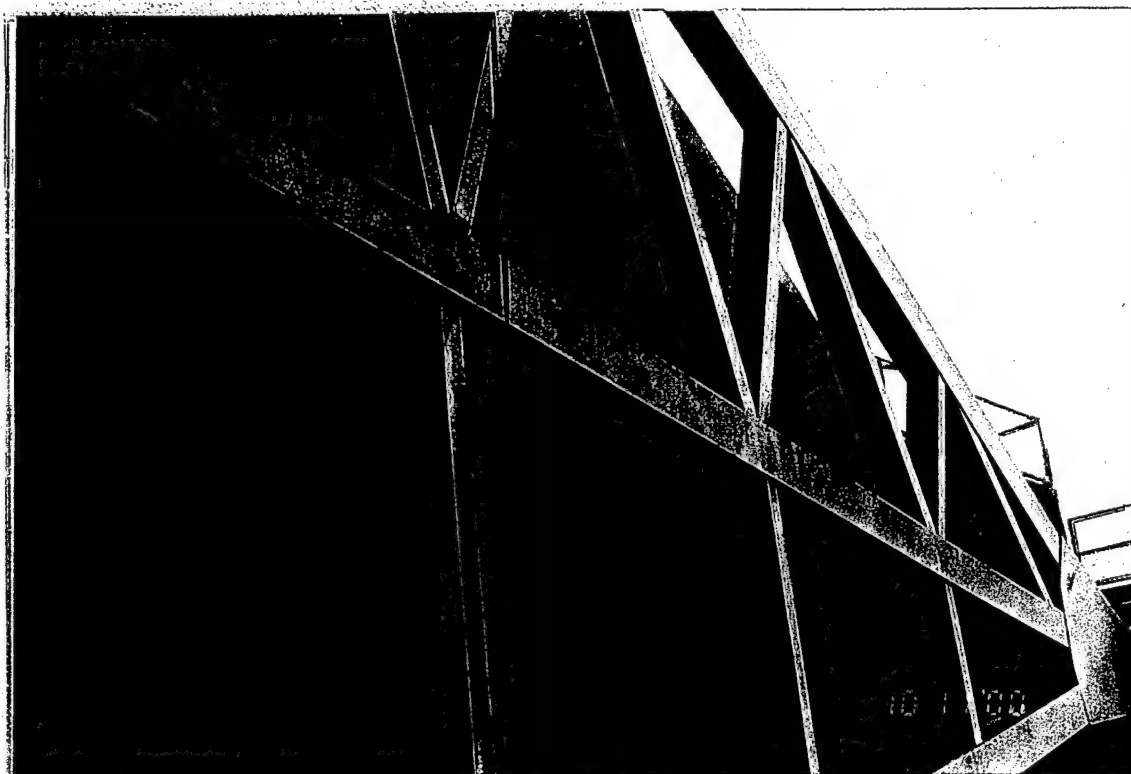
Bottom seal closure plate. Standing  
water between closure plate, purlin  
webs and skinplate, typical.

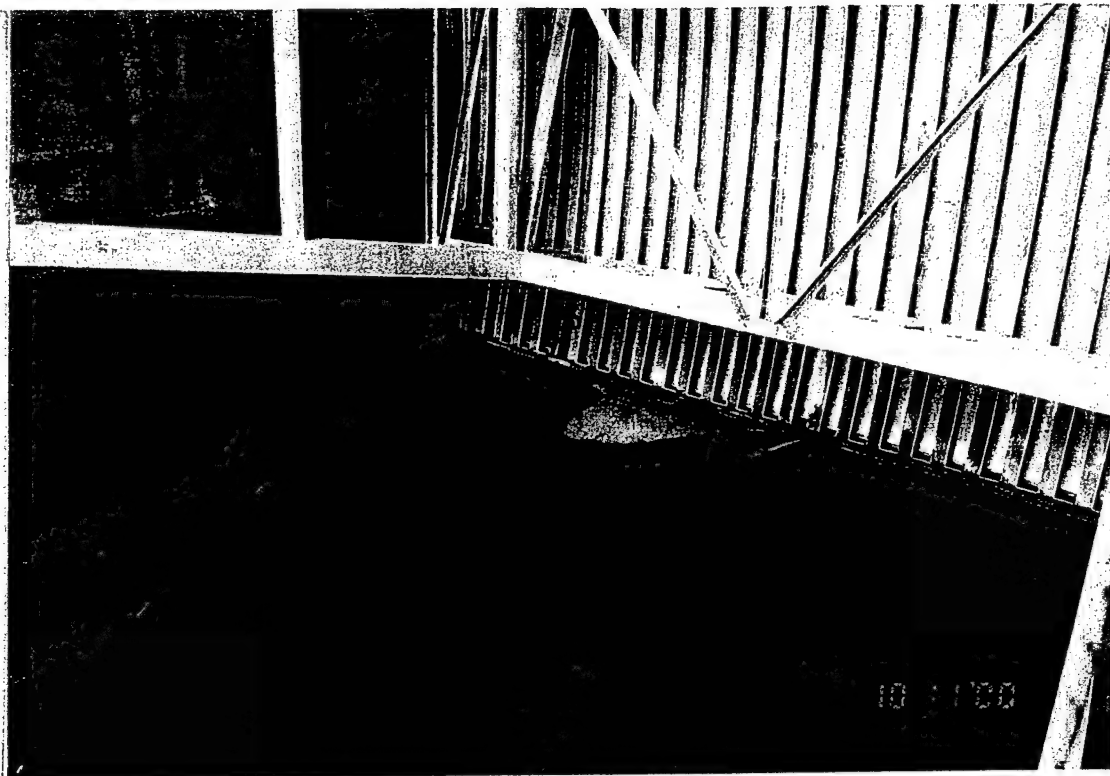
Light corrosion and debris coating on  
braces, typical.

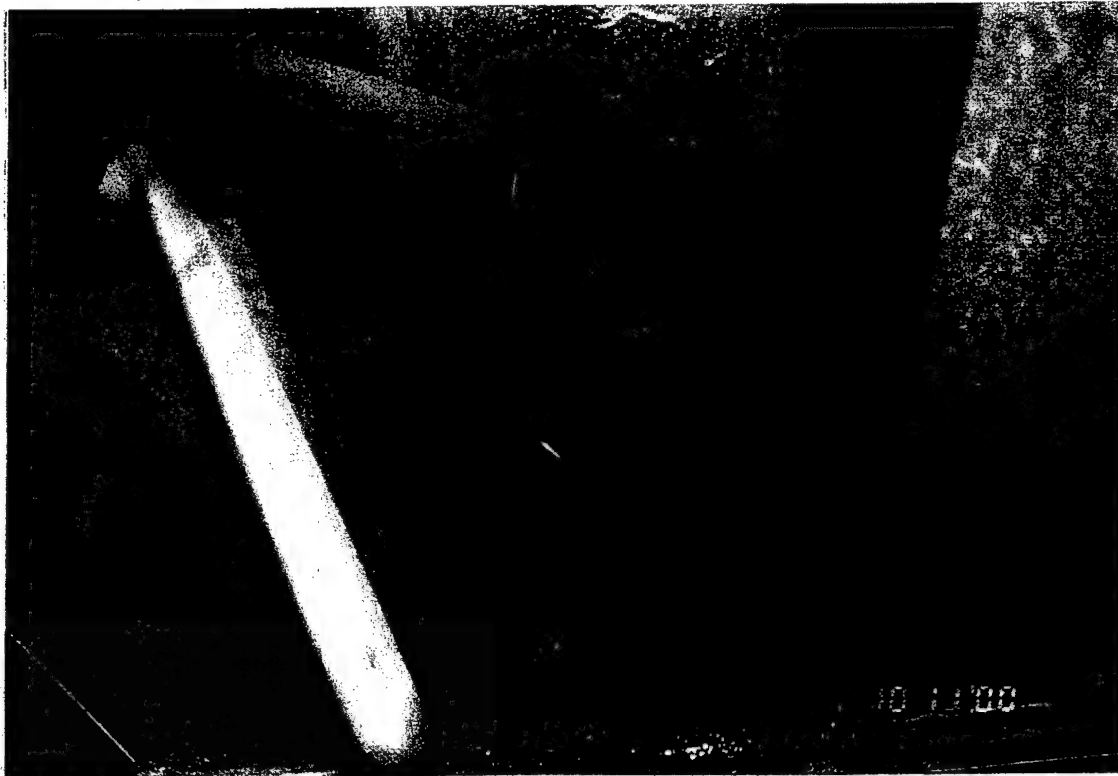
Leak at center construction joint in  
spillway monolith.

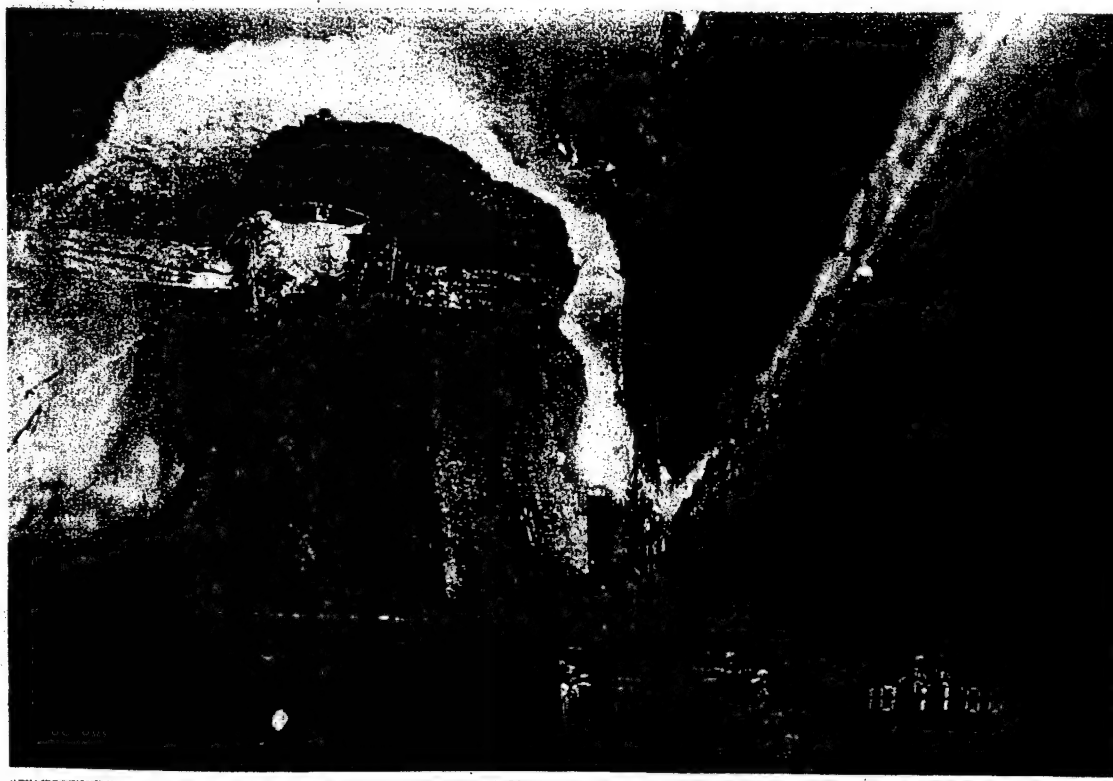
Bottom seal closure plate, standing  
water between closure plate, purlin  
webs and skinplate, typical.

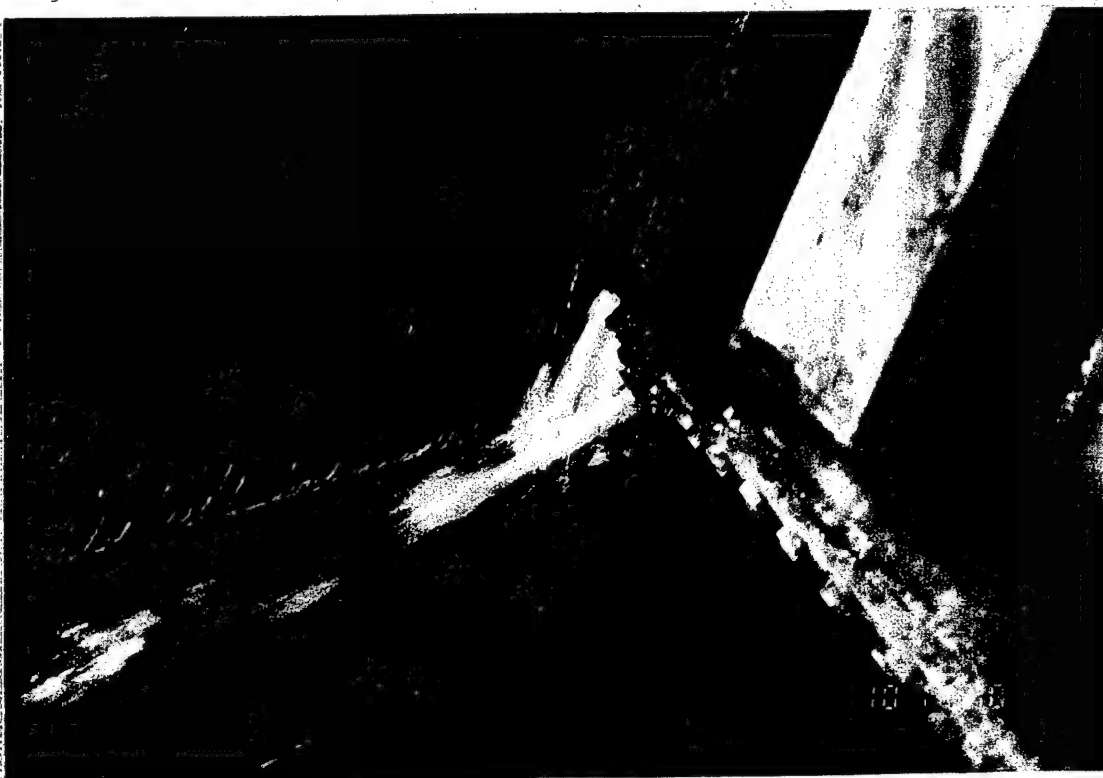
Gate 6  
Side seal leak, bottom left side of  
gate. Light corrosion on purlin,  
horizontal girder and girder  
stiffeners.

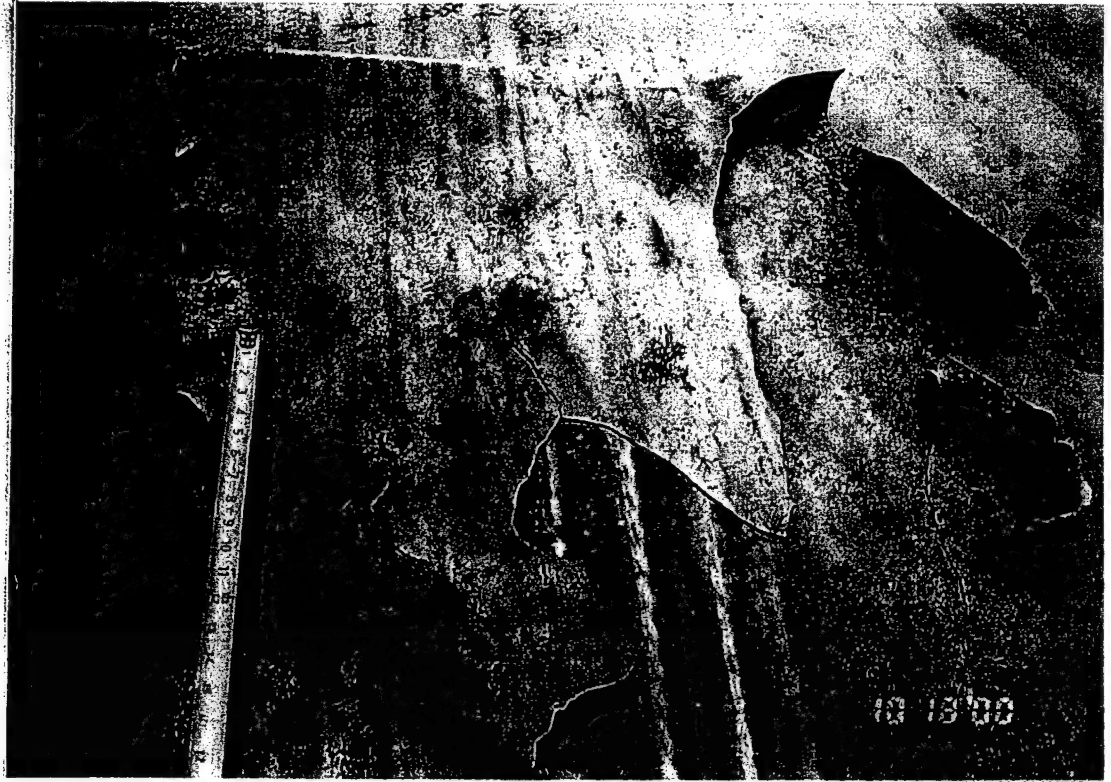
Gate 6  
Left wear plate. Delaminated vinyl  
coating.

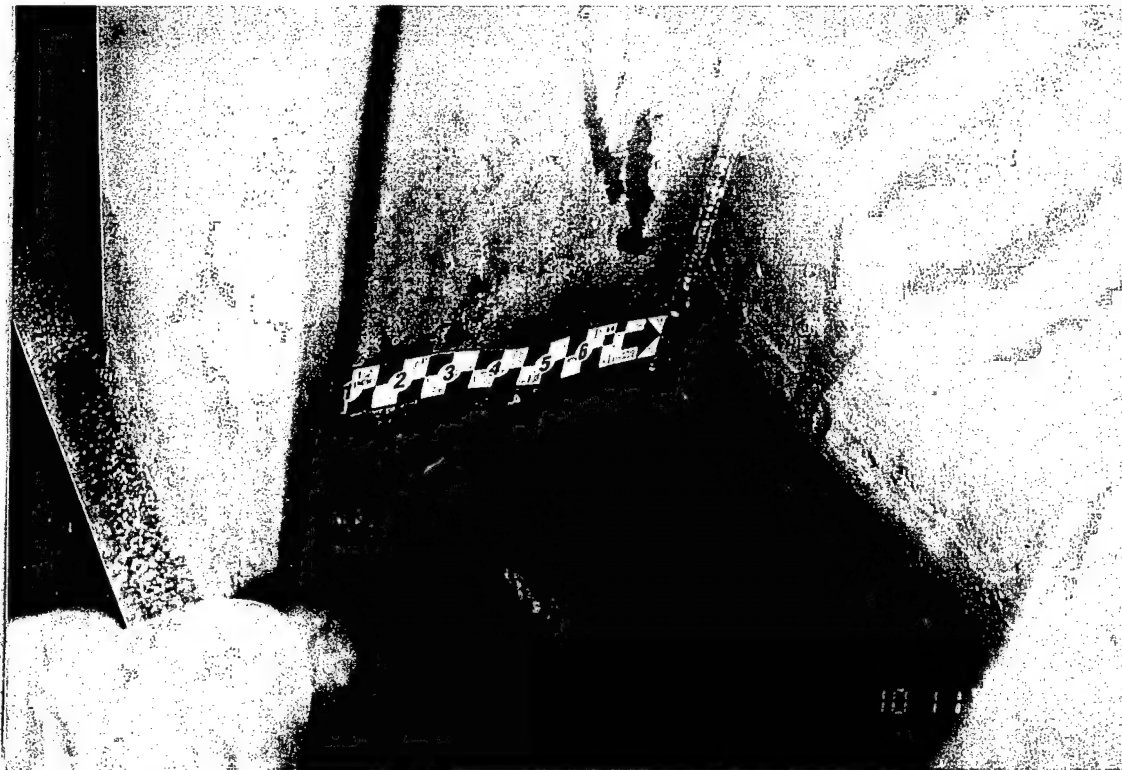
Bottom seal closure plate looking  
upstream. Standing water between  
closure plate, purlin webs and  
skinplate, typical.

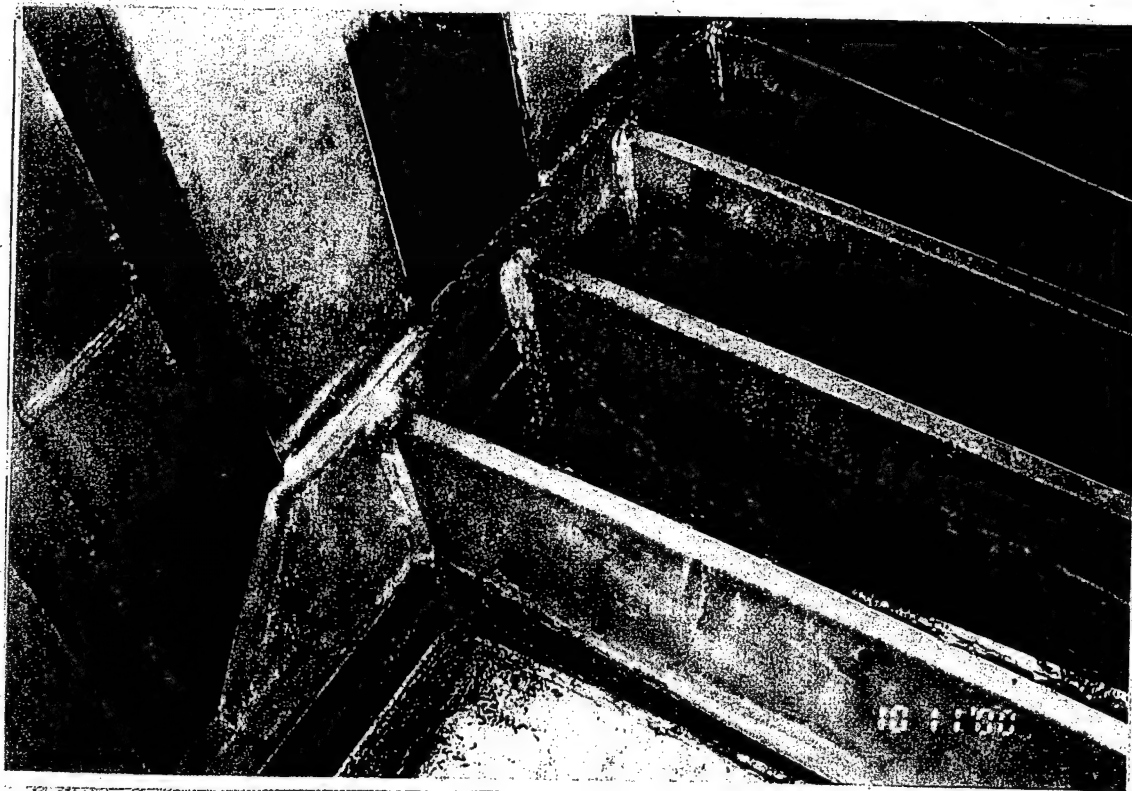
Bottom horizontal girder, left end.  
Standing water, no drainage between  
multiple stiffeners, typical.

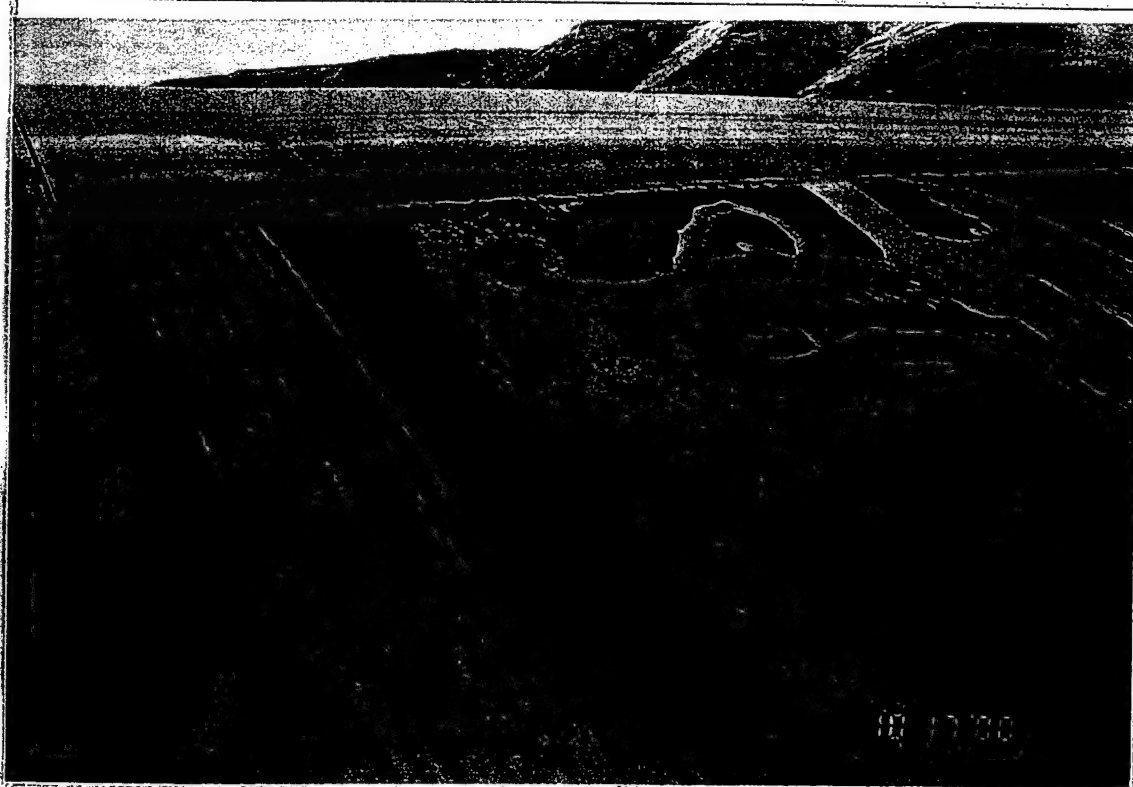
7-24

Gate 7  
Wear plate condition, typical.

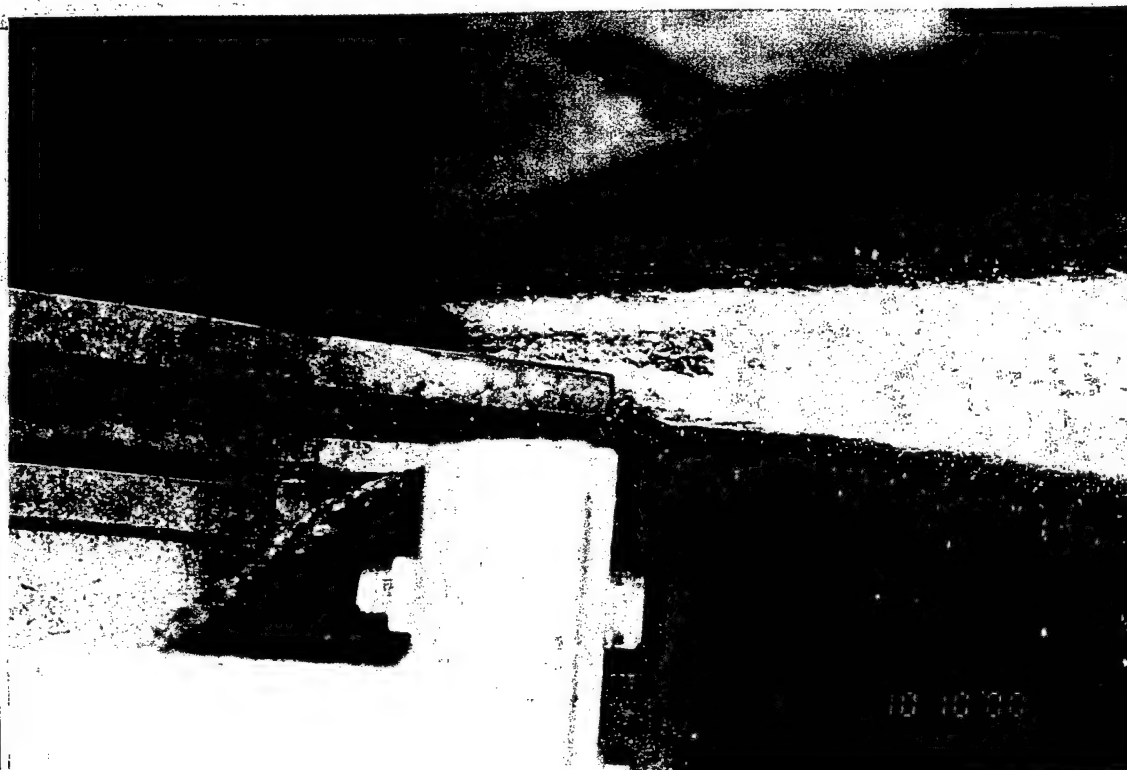
Bottom seal closure plate, standing water between closure plate, purlin webs and skinplate, typical. Leak at center construction joint in spillway monolith.

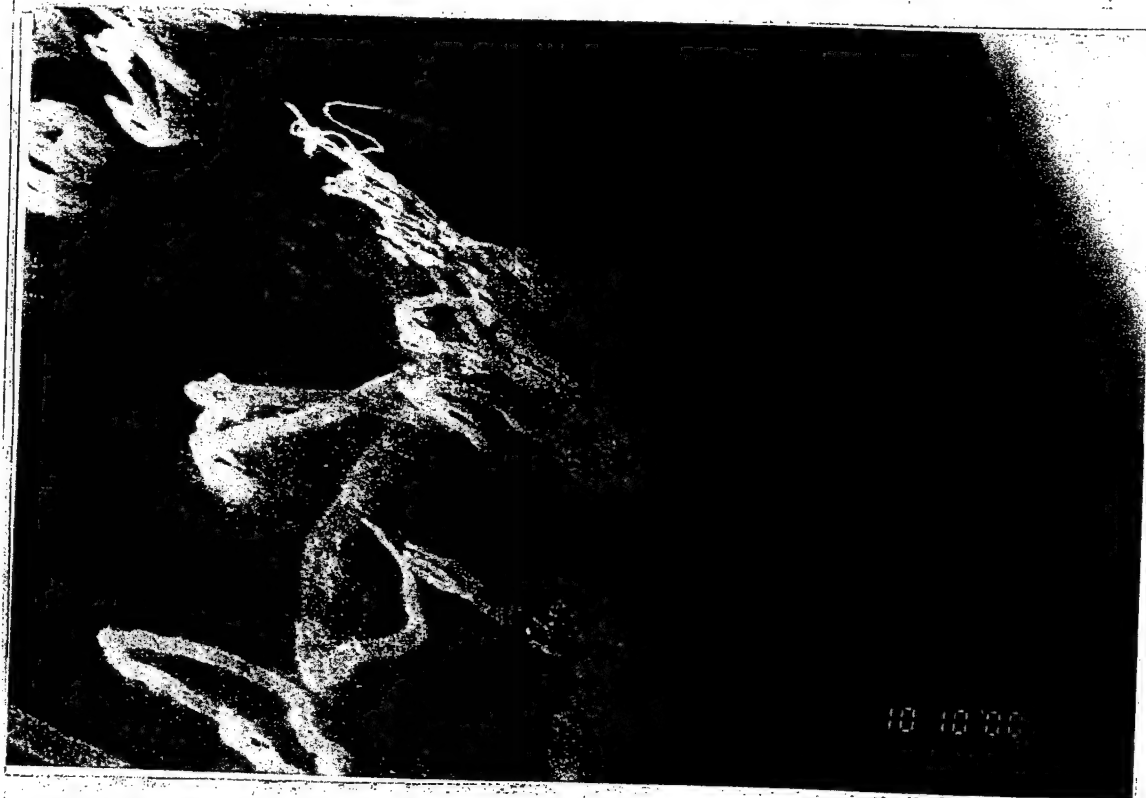
Typical upstream skin plate  
condition, heavy concentration of  
pitting.

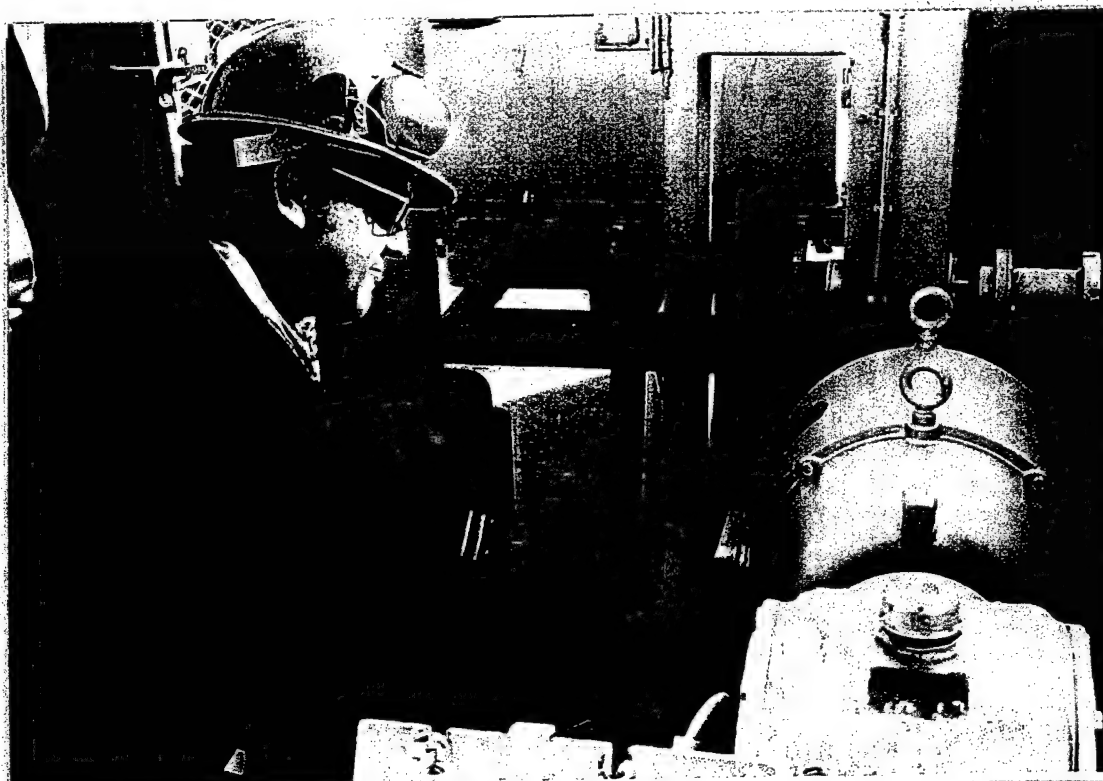
M-2

**Hoist and Mechanical**  
Amperage readings during  
operational testing, typical.
